*There Are Lessons to Be Learned from the  
October 1999 Fire and PCB Accident  
in the Herbert C. Hoover Building*

*Final Inspection Report No. IPE-12453/March 2000*

*Office of Inspections and Program Evaluations*

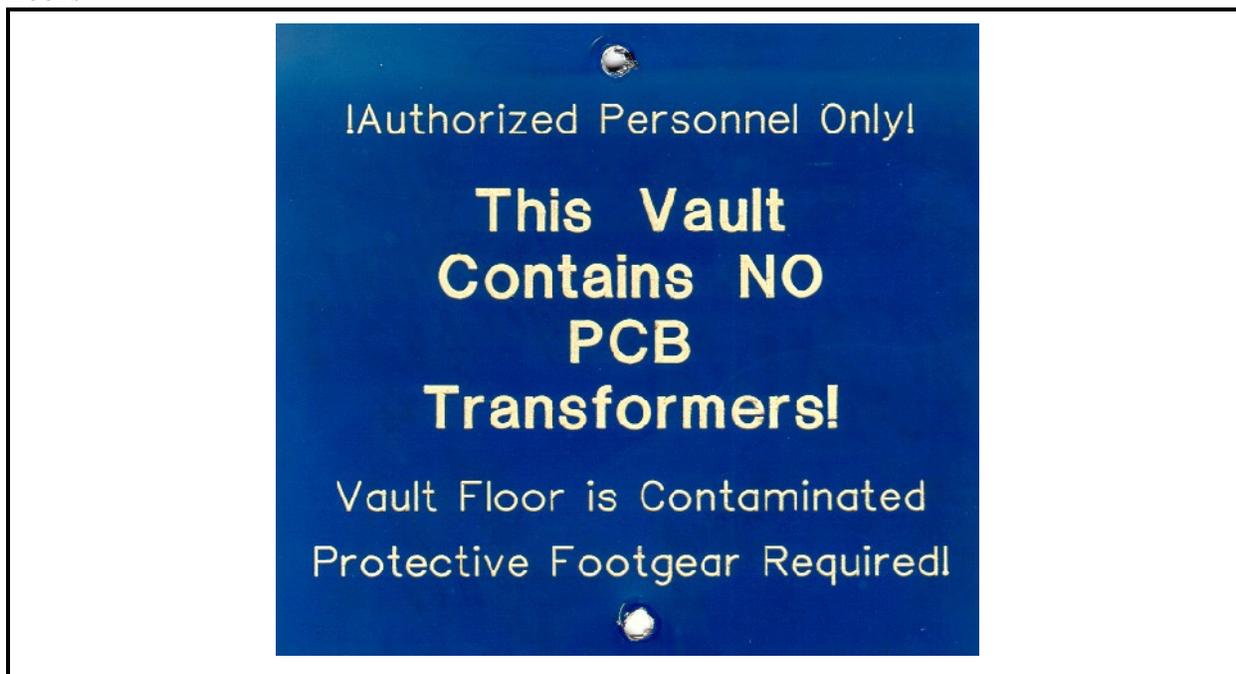
We were told that in 1993 GSA placed signs on the eight vault doors warning of contamination and the need to wear protective footgear (see Exhibit 1 on page 9.) However, when we inspected the vault doors, we found that the warning sign was present on just two of the eight vaults. GSA and departmental officials told us that sometime in the last year or two, GSA undertook a project to replace the doors in the building. When the old doors were removed, the warning signs were apparently not moved to the new doors. GSA officials were not certain why the signs were not moved to the new doors, but they pledged to put up new signs as soon as possible. Warning

**Exhibit 1: Warning sign that was posted on two of the eight vaults with contaminated floors**

There were also problems with both the wording and visibility of the signs that were posted at the time of the fire. The Fire Department took particular exception to the signs' wording and found it to be very misleading. In quickly reading this sign on two of the eight vaults, Fire Department personnel assumed that there were no PCBs in the rooms, which was inaccurate. The signs, while technically accurate, were not helpful in an emergency situation. The large print, stating that there are no PCB transformers, tended to overshadow the smaller print warning of contamination and of the need for protective footgear.

The new signs that were posted on January 14, 2000, are an improvement over the old ones in that they better highlight the contamination factor and de-emphasize the fact that the transformers are PCB-free. However, the new signs now say that the vault floor "may be contaminated." It is our understanding that, due to the passage of time, cognizant GSA personnel believe that the vault floors may no longer be contaminated. However, no testing has been done to verify this assumption. Therefore, we are recommending that the Department work with GSA to have the vault floors retested. If the vault floors are still contaminated, then the Department should consider resealing them with an epoxy sealant or other protective material to eliminate or further minimize the spread of contaminants from the floors. Once the contamination factor of each vault is known, the Department, in conjunction with GSA, should

remove the current warning signs and replace them with either a sign that simply states that the vault contains no PCB transformers or a warning sign that stresses the contamination factor and the need for protective footgear.
